ASSUNPINK DAM

NJ 00198

PHASE 1 INSPECTION REPORT
NATIONAL DAM SAFETY PROGRAM

April, 1979

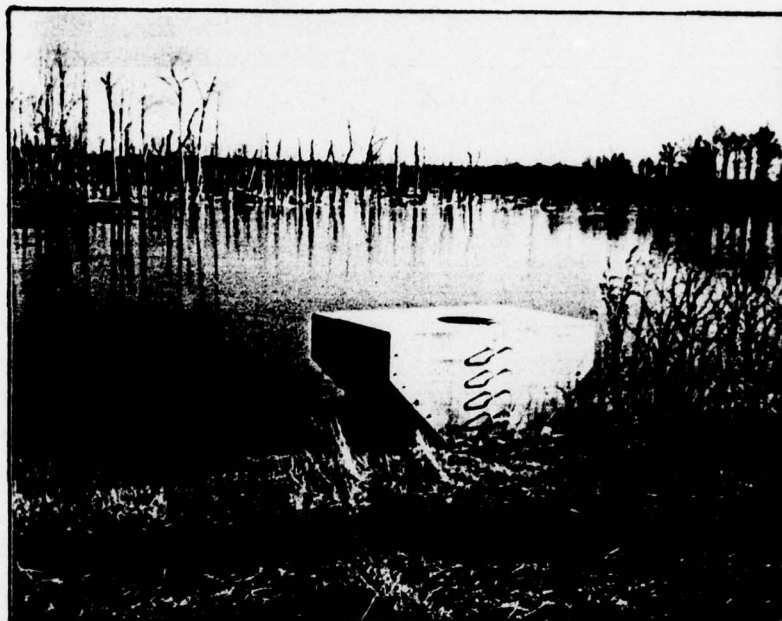
View of intake structure

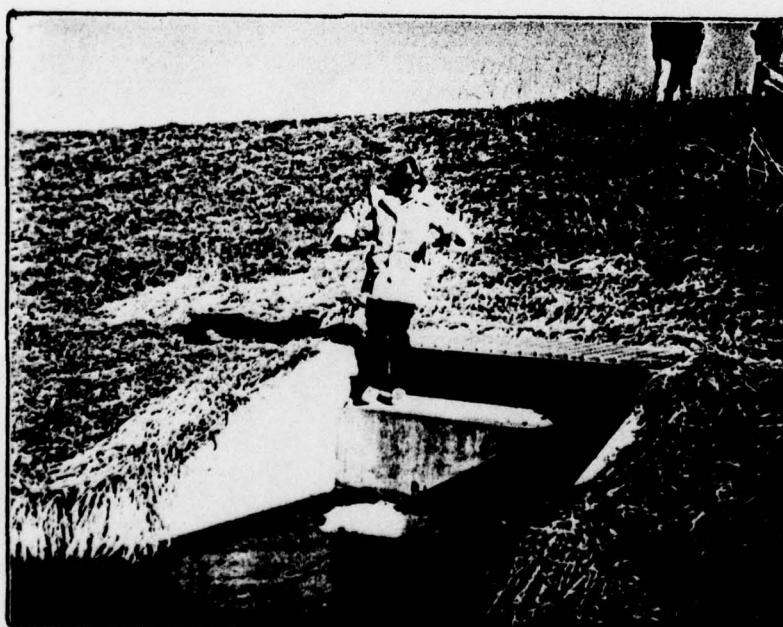
View of outlet structure

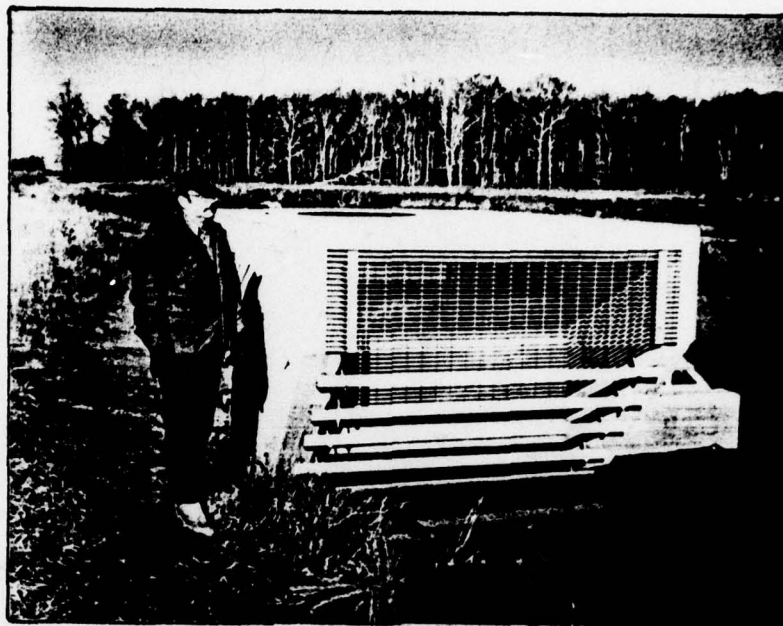
The intake structure was accessible at the edge of the water during the inspection since the lake was 1.5 feet below normal pool. The concrete, grating, and trash racks are in excellent condition although some very light spalling on the lakeside edges of the concrete was noted. Several of the stop logs of the low stage weir had been recently removed by bureau personnel to lower the reservoir to its present pool. The impact basin appeared to be in good condition and functioning as designed. The concrete and safety grate appeared to be satisfactory, and water stains on the concrete indicated that the tailwater was several inches below its normal elevation. The grass covered auxiliary spillway exhibited some vehicle tracks although not as prominently as noted on the dam embankment. This spillway originates in a wooded area near the right abutment, curves around the right end of the dam, and terminates several hundred feet downstream in a small stand of trees. The plans indicated a buried concrete grade beam at the crest of the spillway but this was not located in the field.

Intake structure

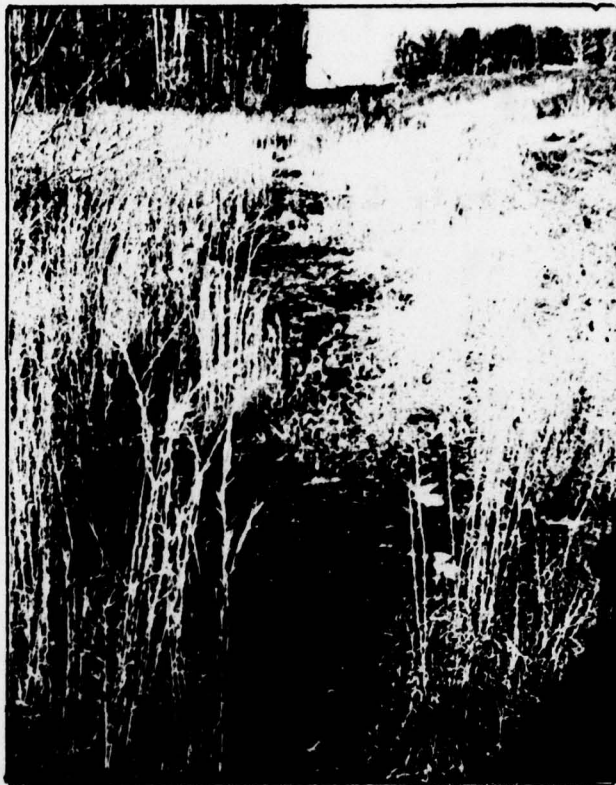
Seepage noted along toe of left abutment. (See photo).

View of seepage at toe of embankment

- Regrade the eroded backslopes and rutted dam crest and reseed all bare areas.
- Continue to monitor the foundation seepage and the subgrade drainage system.
- Place additional vehicular barriers at various locations to inhibit the illegal vehicular use of the dam surfaces.
